# Manhole Inspection Summary

Manhole # S53M\_\_038MH

Insp Date: **3/12/09 2:20 PM**

**Location** Address: **928 s ellwood ave**

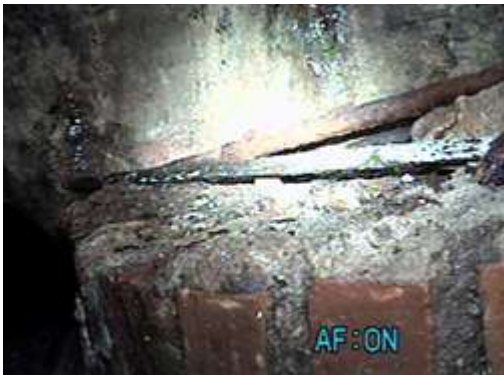
Defect 5

Condition: ☒ Sound ☐ Cracked ☐ Root Intrusion ☐ Deteriorated ☐ Leaks ☐ Debris

bench debris

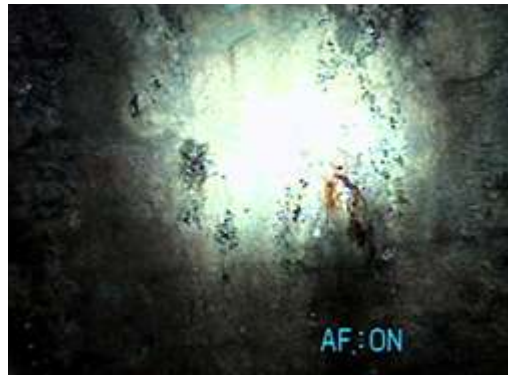
Defect 3

Infiltration: ☐ None ☐ Joint ☐ Cracks ☐ Mortar ☐ Roots ☒ **Wall**

barrel wall infiltration

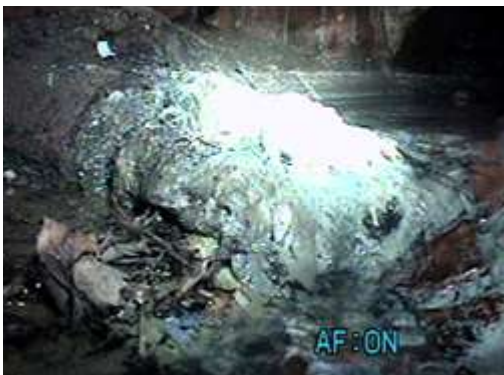
Defect 2

Condition: ☐ Sound ☐ Cracked ☐ Root Intrusion ☐ Deteriorated ☐ Leaks ☒ **Debris**

channel debris

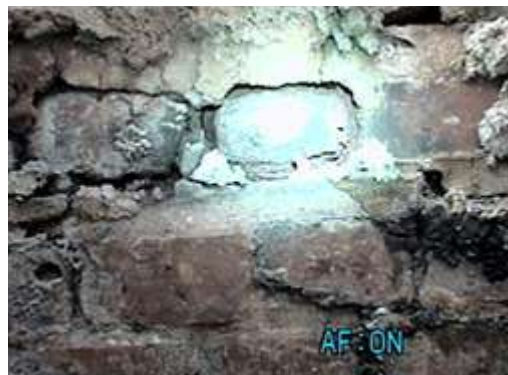
### Defect 1

Condition: ☐ Sound ☒ **Cracked** ☐ Root Intrusion ☒ **Loose Brick** ☒ **Deteriorated**

frame adj cracked, loose bricks,  
deteriorated

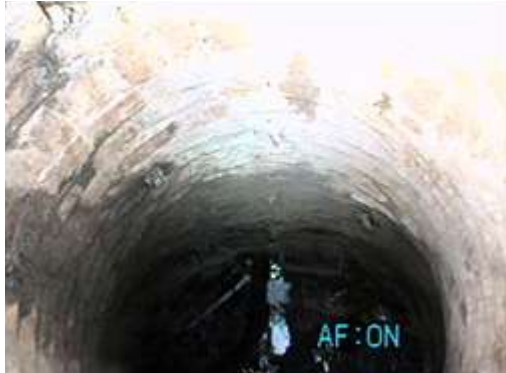
Count: **4** Missing: **3** ☒ **Corroded**

missing/corroded steps

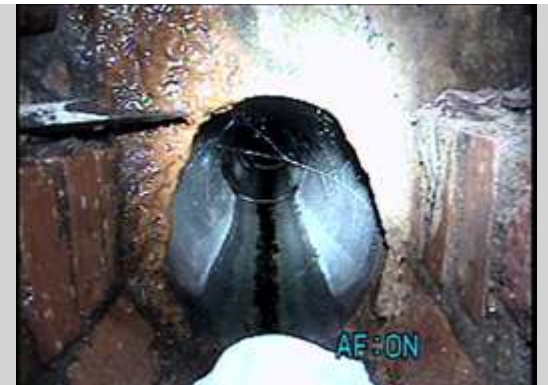
3 O'Clock Inflow

also barrel infiltration
